SealGuard / Sub-Technical Case Study – Crack Injection – Fresh Water Pump Station

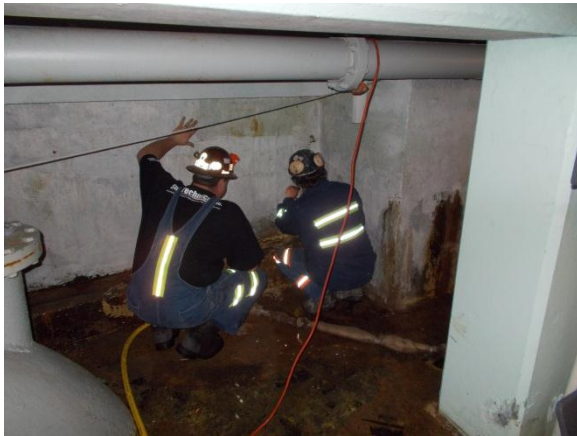
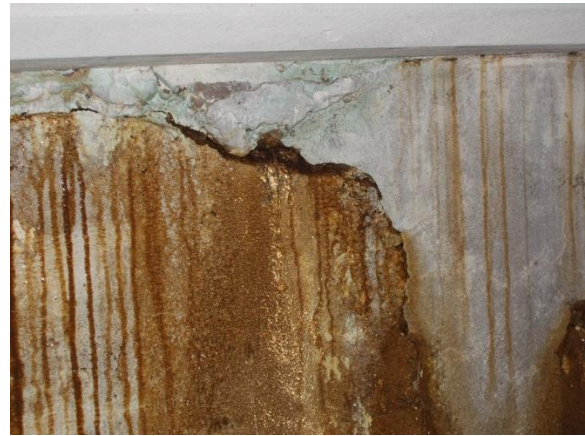
Example of the leaks formed in basement walls.

As according to our original plan, we began inside the basement of the pump station. We used SealGuard II tube sets to shut off the most aggressive water infiltration, then packers, an electric grout pump and 5 gallon pails of HyperFlex. Divers were stationed on the other side of the wall in the sluice area to warn if any urethane foam was escaping into the water (none did). In addition to crack injection, we used HyperFlex to fill voids on the outside of the basement walls caused by years of water flow. As we filled these voids we noticed water levels in the excavation pit were lowering somewhat from where they were when we started as we effectively pushed the water back and held it in the sluice with HyperFlex. Just to give an idea of the magnitude of the leaks in the basement, we used 24 tubes of SealGuard II and 350 pounds (Seven 5 gallon pails) of HyperFlex.

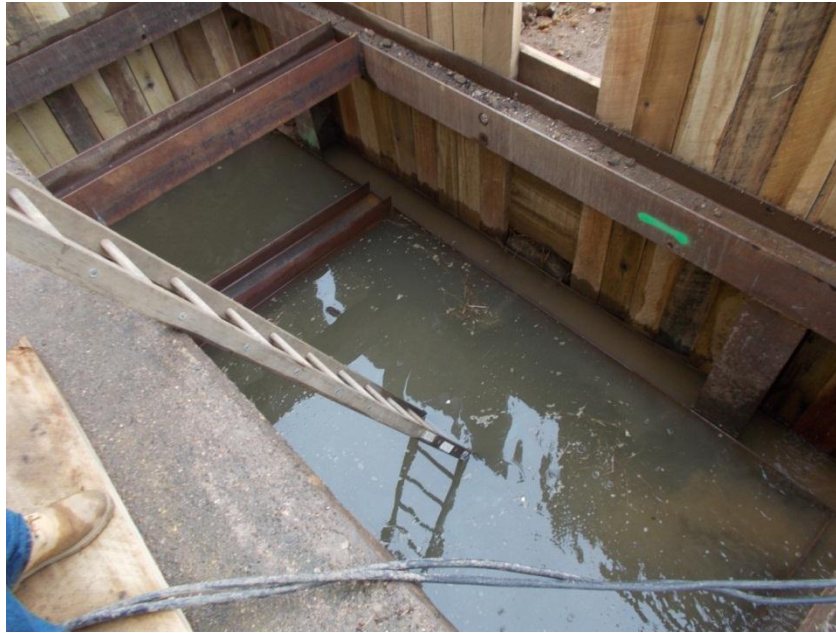
The second part of this grouting project was to take place outside, where a seriously leaking manhole and the main leaks identified by the ROV were to be excavated and exposed then grouted from the outside. Unfortunately, the excavation contractor hit six feet of solid concrete just 1/3 of the way into what was to be a 15 foot deep excavation. This left us no way to safely inject urethane directly into the leaks on the exterior of the sluice or water tunnel.

The picture below shows the cumulative effect of the multiple leaks into the partial excavation pit.

We were still left with substantial leaks coming from the areas of the tunnel and sluice gates we could not reach because of the unforeseen concrete slab. Our solution made this project into a very interesting combination of the most modern polyurethane grouting formulations and one of the oldest leak stopping materials available; Oakum Rope. The only way to access these cracks in the walls of the tunnel and sluice was from the inside, and fixing a 1 ½ in wide, 8 foot long crack under 8 feet of water is not easy at all, especially when it is impossible to use grout. We had the divers take the rope and, using a putty knife, force it into the cracks. The oakum expands as it gains water and forms an extremely tight, if somewhat temporary (3-5 year) seal. Since divers go into the tunnel for routine inspections every 12-24 months, the cracks can be inspected and re-chinked when necessary

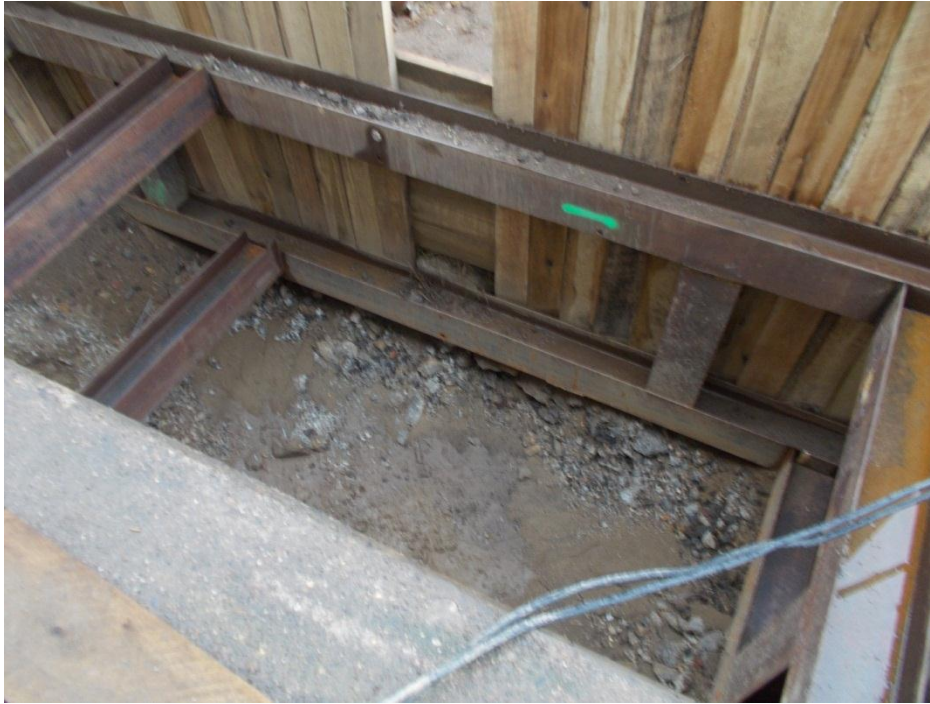
After shutting off the remaining small leaks over the next day or so, flow into the excavation pit was next to nil. This project is a great reminder that sometimes the oldest technology can work better than the newest, in certain circumstances!

The excavated pit at the conclusion of our project

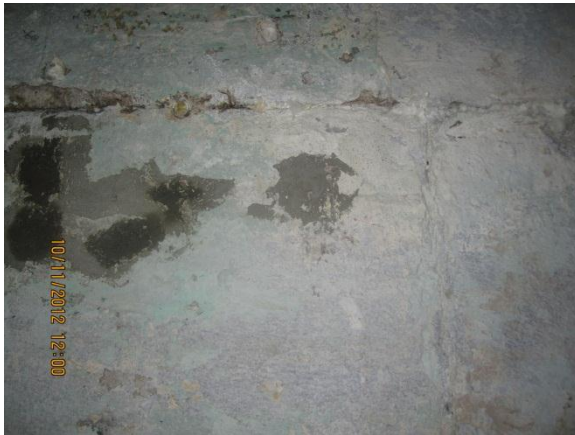
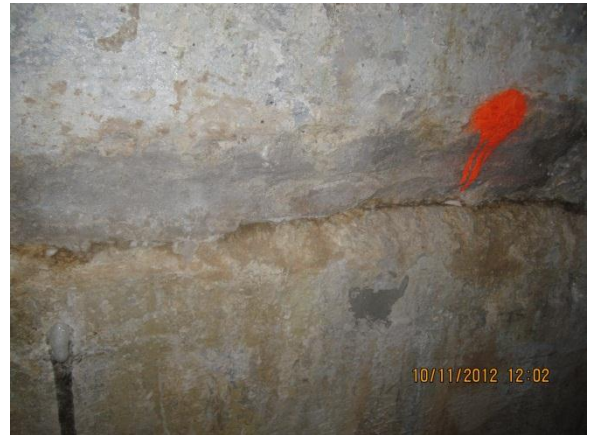
These photographs show the dry basement wall after our grouting project. The darker areas are from the hydraulic cement we used to repair our injections sites.
