Case Study

HyperFlex Fixes Seriously Leaking Swimming Pool

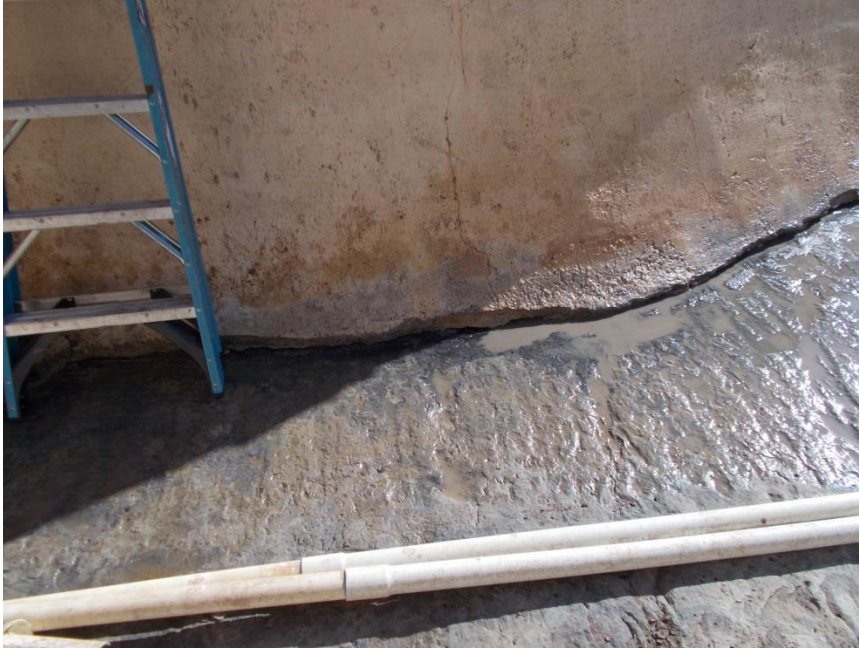
The pool was constructed by first, damming an inlet on a man-made lake (or tank as it is called in Texas) then excavating down to bedrock at around 16 feet. Approximately 12” of gunnite was then applied to the walls of this man-made swimming hole, which is 90 feet long and approximately 40 feet wide. Over time 2 basic factors conspired to cause ever worsening leaks, to the point where the pool was unusable. The first factor was the gunnite walls. Gunnite, like all cementitious products, is somewhat hydrophilic, meaning that it will shrink over time as it cures and dry out. In this case, the walls pulled up and away from the floor, leaving a sizable gap for water egress and ingress.

Fig 2: This photo shows how the gunnite has shrunken from the bedrock floor.

This led to the loss of thousands of gallons per day when full and allowed large amounts of fine, silty clay to enter the pool in high rain events. It also caused significant voids behind the wall which we discovered when drilling our injection holes
