## Case Study

### HyperFlex Fixes Seriously Leaking Swimming Pool

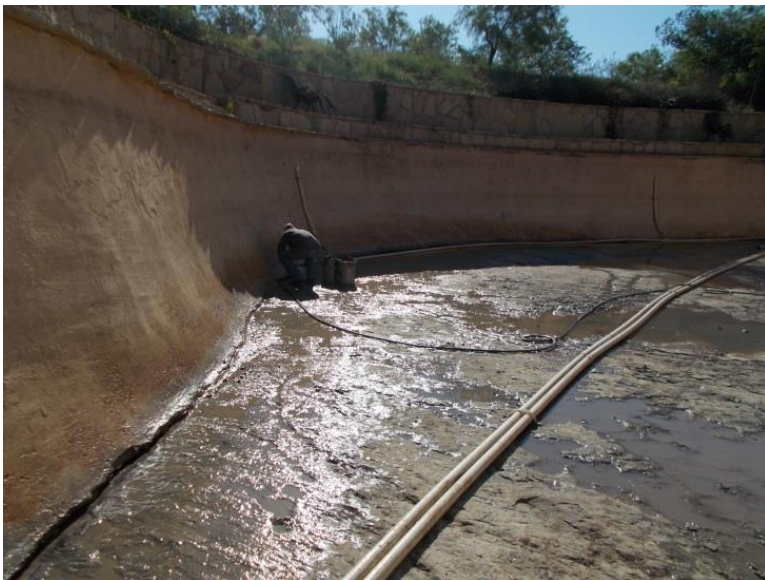
**Fig 1: The Subject Pool, as the gap between the wall and floor is cleaned with a high pressure water stream and loose debris removed.**

1. We started by breaking out the loose, cracked hydraulic cement from a previous repair attempt as well as washing out loose dirt and debris with a hose as best we could.
2. Using SealGuard II, we injected face of the largest openings, (those over ½” or so) to serve as a chemical “chinking”. We then followed with dry oakum rope and, using a putty knife, forced it into the smaller cracks where we could.

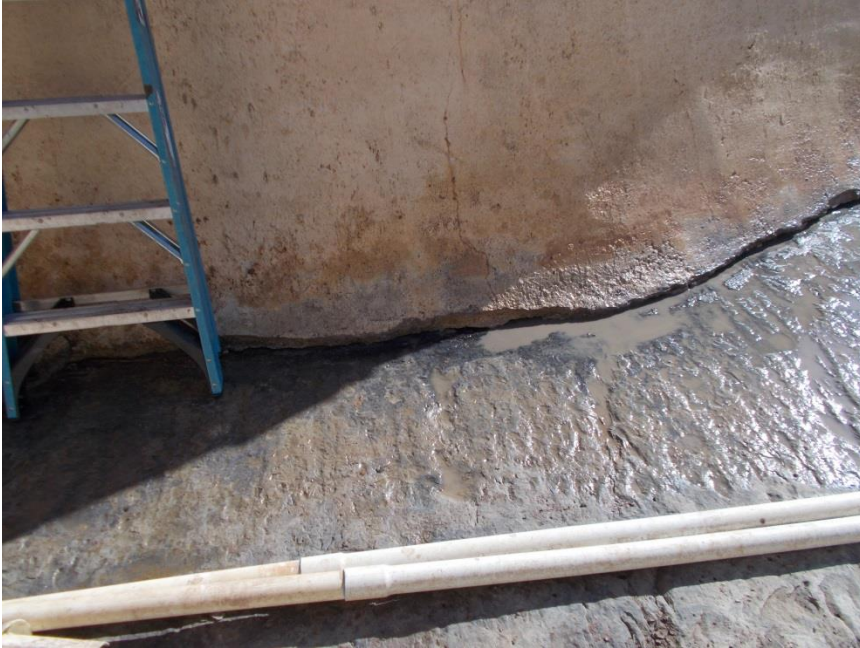
The pool was constructed by first, damming an inlet on a man-made lake (or tank as it is called in Texas) then excavating down to bedrock at around 16 feet. Approximately 12” of gunnite was then applied to the walls of this man-made swimming hole, which is 90 feet long and approximately 40 feet wide. Over time 2 basic factors conspired to cause ever worsening leaks, to the point where the pool was unusable. The first factor was the gunnite walls. Gunnite, like all cementitious products, is somewhat hydrophilic, meaning that it will shrink over time as it cures and dry out. In this case, the walls pulled up and away from the floor, leaving a sizable gap for water egress and ingress.

**Fig 2: This photo shows how the gunnite has shrunken from the bedrock floor.**

This led to the loss of thousands of gallons per day when full and allowed large amounts of fine, silty clay to enter the pool in high rain events. It also caused significant voids behind the wall which we discovered when drilling our injection holes

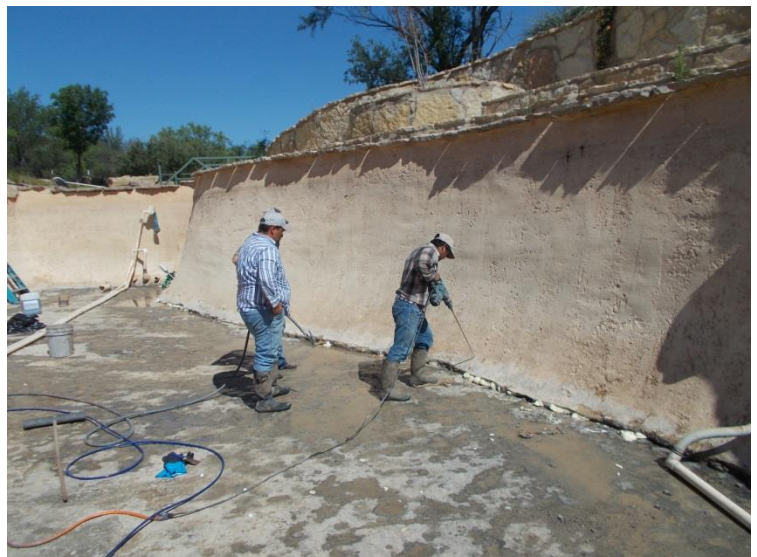
**Fig 3: Drilling 5/8” holes for injection packers, Notice the oakum and SealGuard II used to chink the floor/wall gap.**

3. Due to the voids, we elected to drill at an angle to hit the very back corner of the gunnite wall rather than straight back. This way we would be able to fill the gap between the wall using far less material than if it was pumped higher up the wall, into the void and allowed to run into the joint. We started our pattern on 4-6 foot centers and adjusted as we went based on how well the HyperFlex was migrating.

4. Once the holes were drilled at the proper angle, a garden hose was used to flush the drill dust and also to wet down the substrate. 5/8" packers were then installed.

5. An initial injection was performed. We pumped each packer until we had a good show of HyperFlex at the face of the opening.
6. After allowing the initial injection to cure, effectively sealing the interface between the gunnite wall, we then re-injected each packer with ½ - 1 gallon of additional material to fill in the void behind the wall and provide additional strength to the original seal created with the first injection pass.

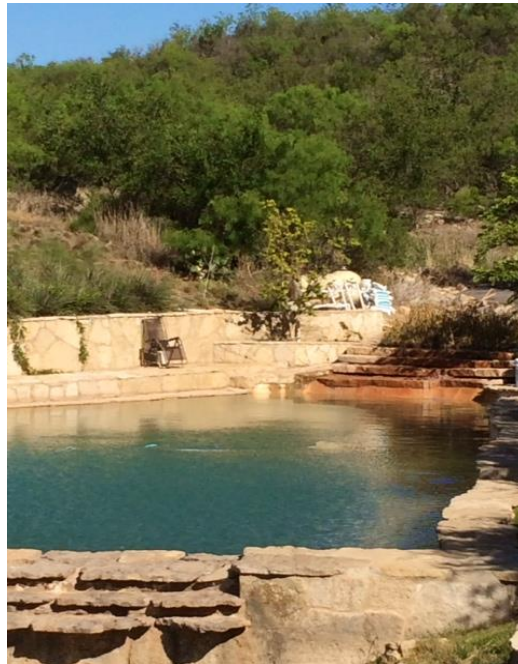
**Fig 4: Complete Pool.**

7. After waiting for the excess material to cure fully, it was scraped off the floor of the pool and disposed of in a regular refuse container. The packers were loosened and pounded all the way into the injection hole, then covered with hydraulic cement or other patching medium.

8. Pool has not lost a drop – it looks great!
