## SealGuard / Sub-Technical Case Study – Crack Injection – Fresh Water Pump Station

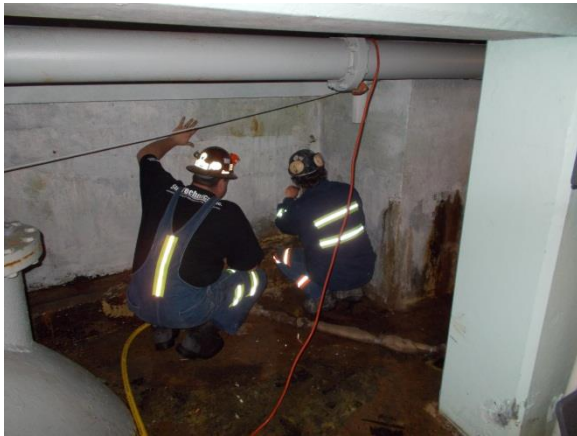
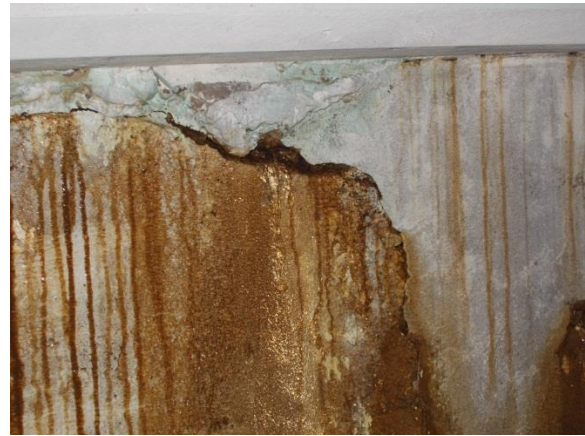
Given the strict need to prevent the escape of any grouting materials into the water supply, (the reason for this was due to fear that reacted urethane could get stuck in the pumps, not because of any particular health hazard, HyperFlex is NSF approved for contact with potable water), it was decided that we would go after the leaks from the outside of the supply tunnel and sluice wall where the sluice gates are joined to the building, an approximately 60'x12' area riddled with cracks and leaking in total 40-50 gallons per minute.

Example of the leaks formed in basement walls.

As according to our original plan, we began inside the basement of the pump station. We used SealGuard II tube sets to shut off the most aggressive water infiltration, then packers, an electric grout pump and 5 gallon pails of HyperFlex. Divers were stationed on the other side of the wall in the sluice area to warn if any urethane foam was escaping into the water (none did). In addition to crack injection, we used HyperFlex to fill voids on the outside of the basement walls caused by years of water flow. As we filled these voids we noticed water levels in the excavation pit were lowering somewhat from where they were when we started as we effectively pushed the water back and held it in the sluice with HyperFlex. Just to give an idea of the magnitude of the leaks in the basement, we used 24 tubes of SealGuard II and 350 pounds (Seven 5 gallon pails) of HyperFlex.

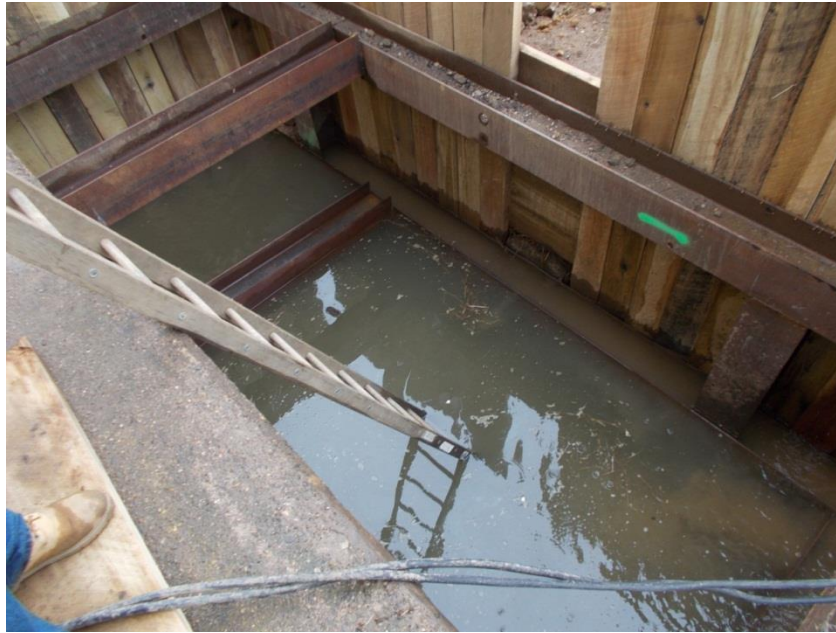
The second part of this grouting project was to take place outside, where a seriously leaking manhole and the main leaks identified by the ROV were to be excavated and exposed then grouted from the outside. Unfortunately, the excavation contractor hit six feet of solid concrete just 1/3 of the way into what was to be a 15 foot deep excavation. This left us no way to safely inject urethane directly into the leaks on the exterior of the sluice or water tunnel.

The picture below shows the cumulative effect of the multiple leaks into the partial excavation pit.

We were still left with substantial leaks coming from the areas of the tunnel and sluice gates we could not reach because of the unforeseen concrete slab. Our solution made this project into a very interesting combination of the most modern polyurethane grouting formulations and one of the oldest leak stopping materials available; Oakum Rope. The only way to access these cracks in the walls of the tunnel and sluice was from the inside, and fixing a 1 ½ in wide, 8 foot long crack under 8 feet of water is not easy at all, especially when it is impossible to use grout. We had the divers take the rope and, using a putty knife, force it into the cracks. The oakum expands as it gains water and forms an extremely tight, if somewhat temporary (3-5 year) seal. Since divers go into the tunnel for routine inspections every 12-24 months, the cracks can be inspected and re-chinked when necessary

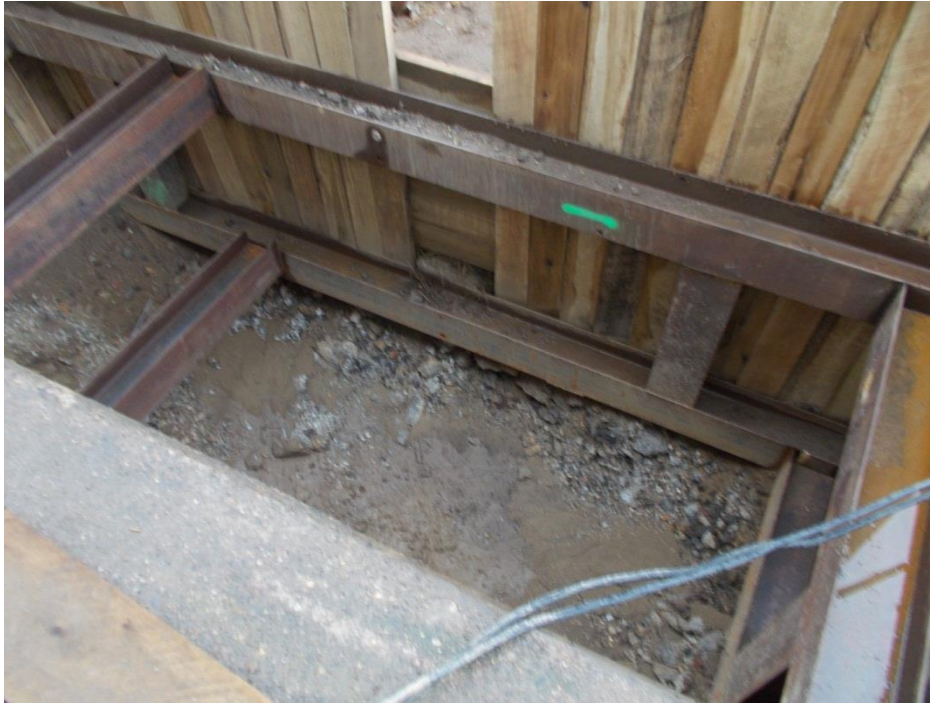
After shutting off the remaining small leaks over the next day or so, flow into the excavation pit was next to nil. This project is a great reminder that sometimes the oldest technology can work better than the newest, in certain circumstances!

The excavated pit at the conclusion of our project

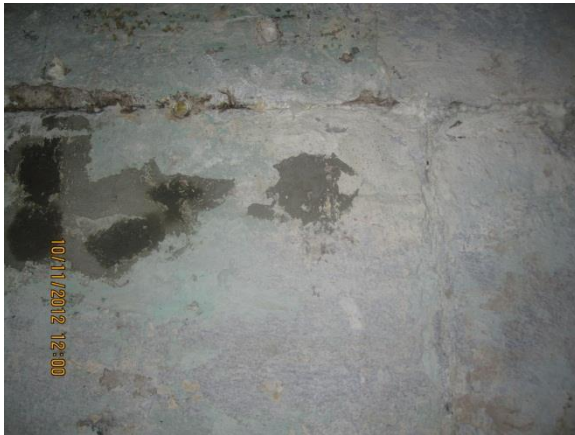
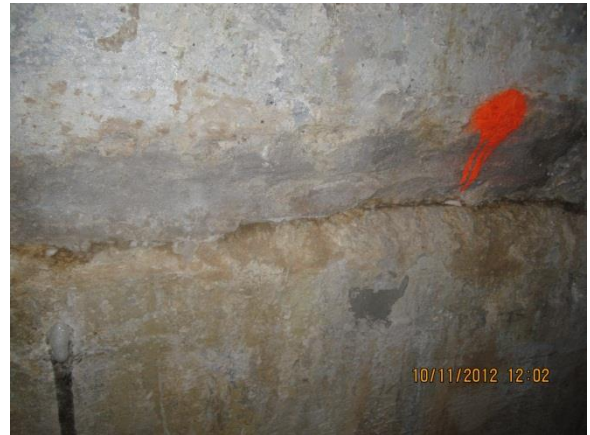
These photographs show the dry basement wall after our grouting project. The darker areas are from the hydraulic cement we used to repair our injections sites.
