Case Study

HyperFlex Fixes Seriously Leaking Swimming Pool

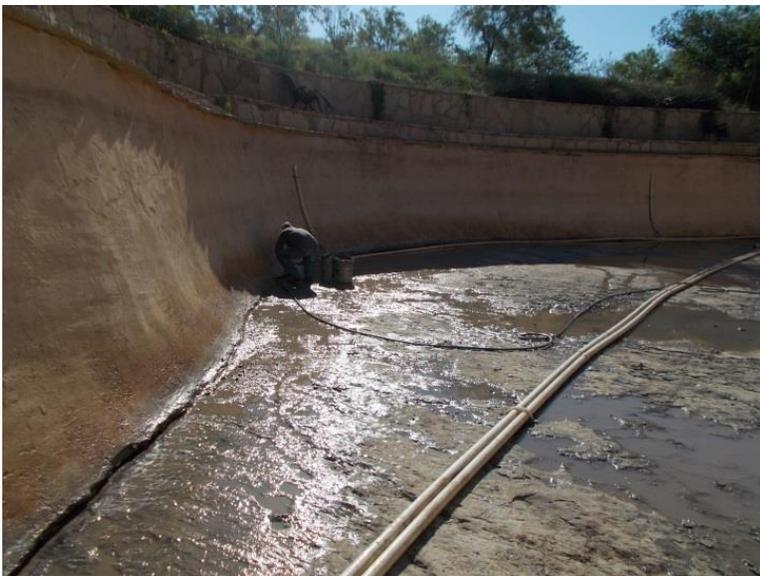
Fig 1: The Subject Pool, as the gap between the wall and floor is cleaned with a high pressure water stream and loose debris removed.

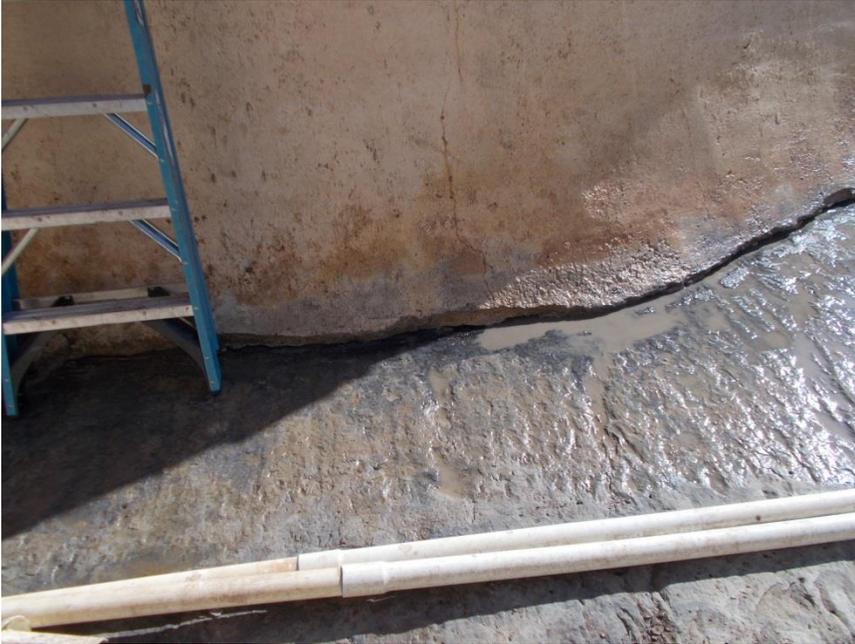
The pool was constructed by first, damming an inlet on a man-made lake (or tank as it is called in Texas) then excavating down to bedrock at around 16 feet. Approximately 12” of gunnite was then applied to the walls of this man-made swimming hole, which is 90 feet long and approximately 40 feet wide. Over time 2 basic factors conspired to cause ever worsening leaks, to the point where the pool was unusable. The first factor was the gunnite walls. Gunnite, like all cementitious products, is somewhat hydrophilic, meaning that it will shrink over time as it cures and dry out. In this case, the walls pulled up and away from the floor, leaving a sizable gap for water egress and ingress.

Fig 2: This photo shows how the gunnite has shrunken from the bedrock floor.

This led to the loss of thousands of gallons per day when full and allowed large amounts of fine, silty clay to enter the pool in high rain events. It also caused significant voids behind the wall which we discovered when drilling our injection holes

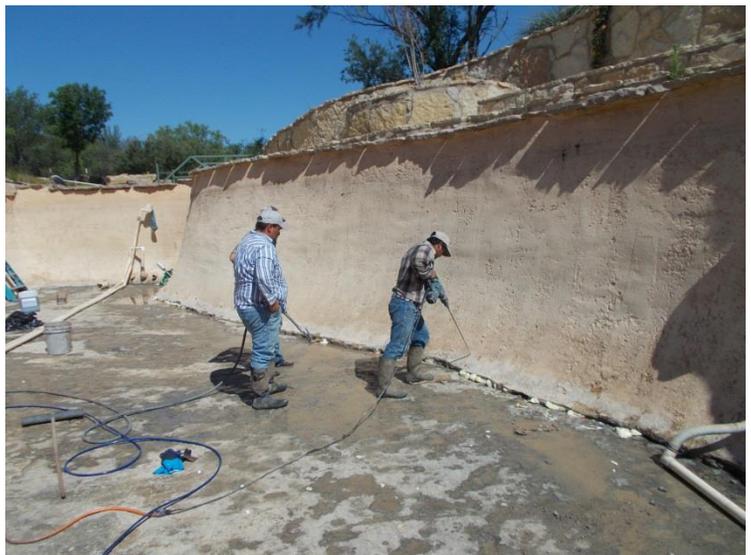
Fig 3: Drilling 5/8" holes for injection packers, Notice the oakum and SealGuard II used to chink the floor/wall gap.

1. We started by breaking out the loose, cracked hydraulic cement from a previous repair attempt as well as washing out loose dirt and debris with a hose as best we could.
2. Using SealGuard II, we injected face of the largest openings, (those over 1/2" or so) to serve as a chemical "chinking". We then followed with dry oakum rope and, using a putty knife, forced it into the smaller cracks where we could.

3. Due to the voids, we elected to drill at an angle to hit the very back corner of the gunnite wall rather than straight back. This way we would be able to fill the gap between the wall using far less material than if it was pumped higher up the wall, into the void and allowed to run into the joint. We started our pattern on 4-6 foot centers and adjusted as we went based on how well the HyperFlex was migrating.

4. Once the holes were drilled at the proper angle, a garden hose was used to flush the drill dust and also to wet down the substrate. 5/8" packers were then installed.

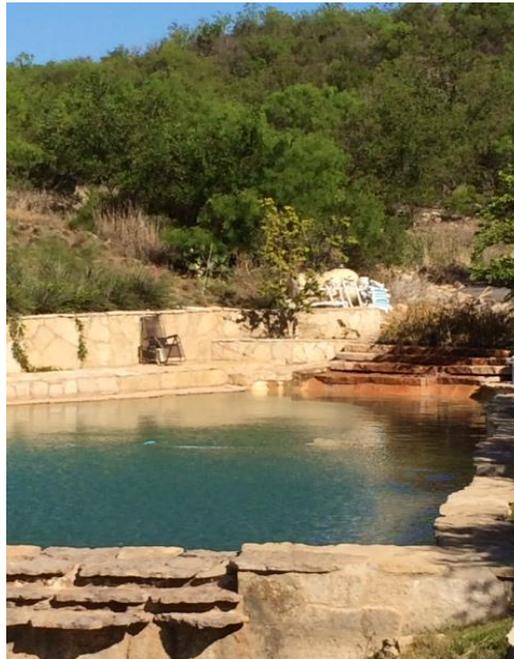
8. Pool has not lost a drop – it looks great!

Fig 4: Complete Pool.
