Water Control-Pre-Cast Cut and Cover Culvert Sections <u>Power Station- Western Pennsylvania</u>

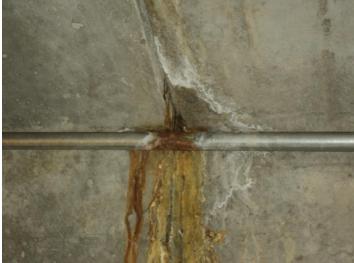
This is an example of the corrosion and rusting of the electrical conduit in the tunnel prior to injection.

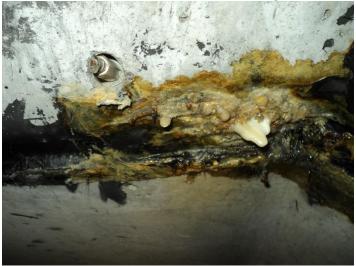
This shows the proper depth to set the packer and also the discoloration & deterioration of the leaking tunnel.

While none of the leaks were particularly large by themselves, the length of the tunnel and the number of leaking joints resulted in quite a volume of water ingress. Due to that fact, we elected to use our Hyperflex material, a single component, pre-catalyzed, hydrophobic grout. Its extended reaction time allows it to flow all through the joint prior to reacting, giving the best possible seal. A converted airless paint sprayer and 5/8 inch injection packers were used to install the Hyperflex. The pre-cast sections were full of rebar, which added to the degree of difficulty in drilling holes to set the packers. Rebar, when hit, will stop a drill cold and many times there is no other choice but to start over and drill again. We intersected the joints about 6 inches or so from the face and injected the joint until a show of material was seen at the face of the joint. The tar strip only filled the first three inches or so of the joint so it served nicely to chink the joint and keep the Hyperflex where it belongs. Given the uniformity of the joint we were injecting it was only necessary to drill three holes in each, one in the ceiling and one each in the two walls.

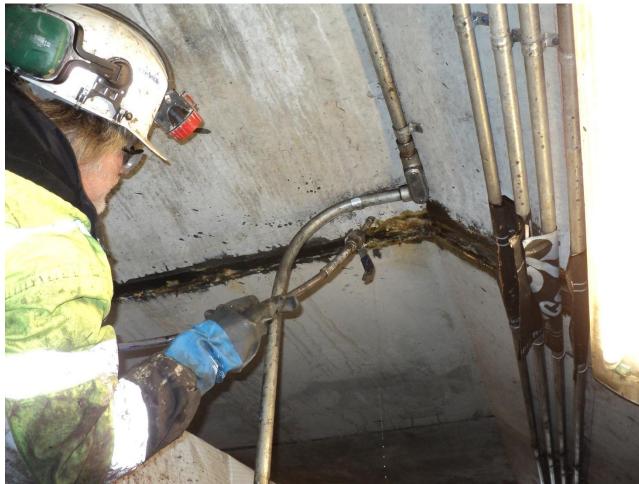
This shows our Sr. project Manager injecting HyperFlex into the joint.

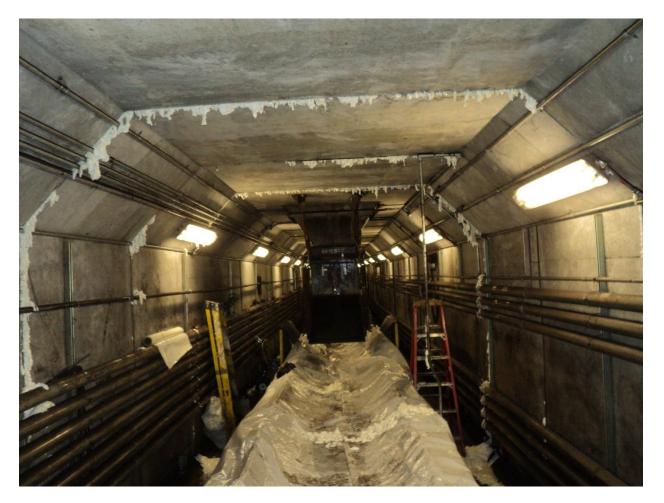
The HyperFlex migrated around the perimeter of the pre-cast joint, expanding and filling it and any voids present out of sight on the other side of the wall. The customer was so happy with the work Sub-Technical did on the leaking joints that we were asked to come back and grout the rest as a preventative measure.
