SealGuard / Sub-Technical Case Study – Ground Consolidation using HyperFlex

Challenge Faced

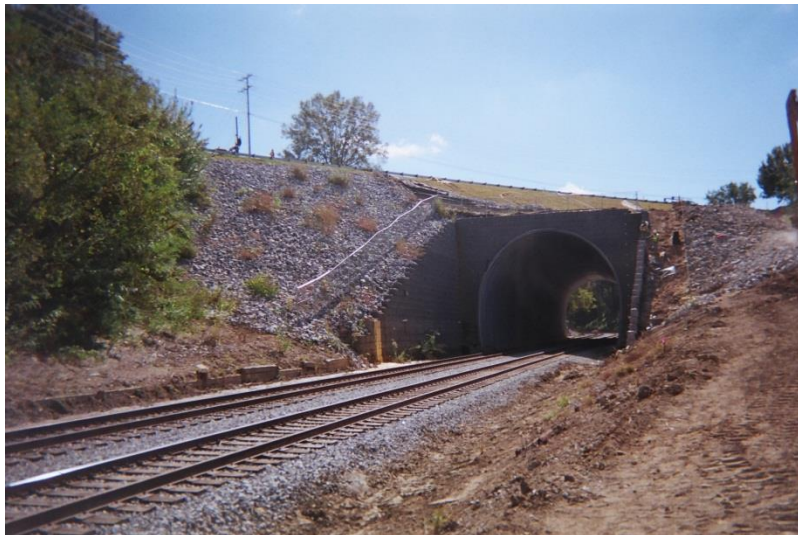
One of our most recent projects was sited at a newly constructed rail tunnel in southern Mississippi that was designed to carry a two lane roadway over it. This tunnel replaced 2 prior bridge structures, which had collapsed. An 800 foot corrugated metal tunnel liner was installed and the small valley back filled using sand and plastic grid material to hold it in place. The roadway was then rebuilt over the tunnel on the compacted fill material. Total depth of the tunnel is 75 feet from the rail bed to the road surface, 20 feet from the top of the tunnel to the road surface. When Hurricane Isaac hit the heavy rain exposed serious problems in the drainage system of the roadway and the design of the road itself. Improperly sealed precast storm drains leaked through the joints and the seals between slabs on the roadway failed. The volume and pressure created by the water scoured large quantities of sand fill from underneath the roadway, causing it to begin to sink. Engineers were concerned that this could lead to a collapse of the road bed with the associated danger to motorists and the tunnel itself.

The project engineers needed to consolidate the remaining fill from just below the roadway to the top of the tunnel. Other materials considered were cementitious grouts, which were ultimately rejected due to their weight and the resultant stress on the tunnel liner. Our HyperFlex product was selected for its ability to migrate good distances through the substrate and the fact that the reacted material in the consolidated ground would not increase the stress on the tunnel.

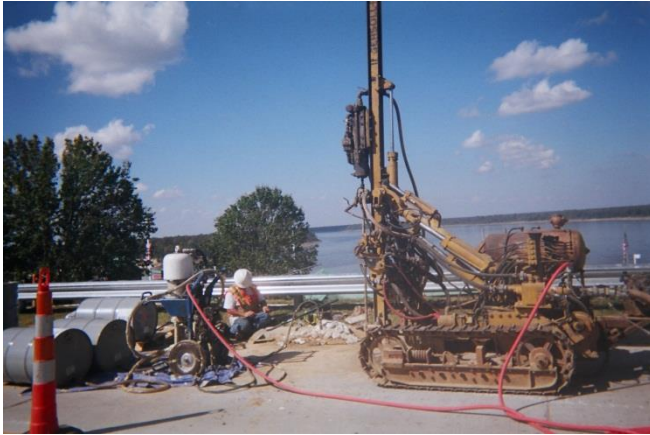
This is our air track machine used to drill bore holes.

Using our air track drill rig, we drilled a grid pattern of 10 and 20 foot deep bore holes. These were placed on 20 foot centers down through the road bed for the length of the tunnel.

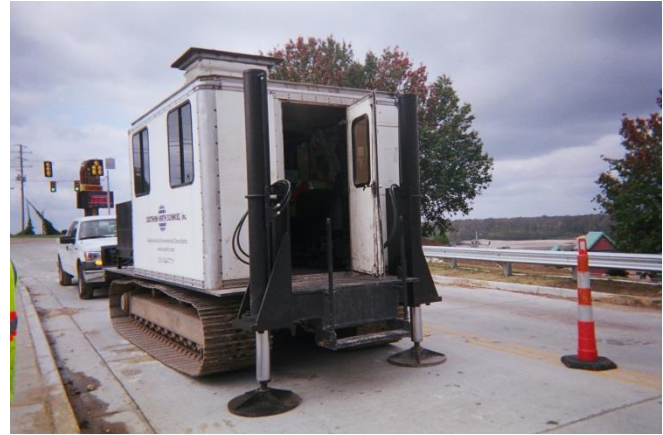
Compaction Penetrometer used to measure ground compaction after grouting.

This project took 6 weeks and amounted to 130,000 pounds of HyperFlex (14,300 gallons). Test bores and compaction tests performed upon cure showed the HyperFlex cured into a very dense (40 pcf versus 2 pcf at free rise) material that compacted the ground above and below it. This will enable the ground to carry the roadway safely into the foreseeable future

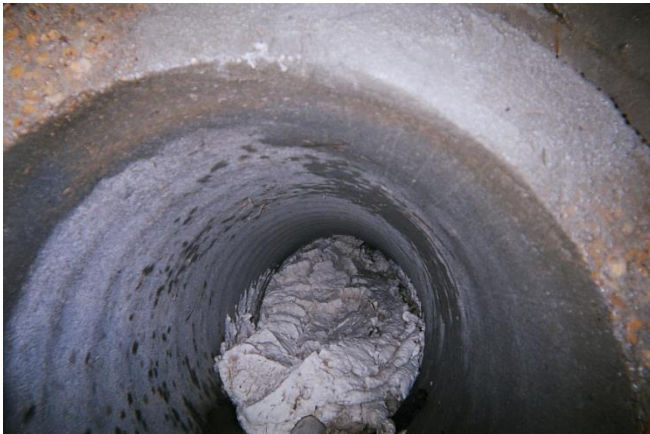
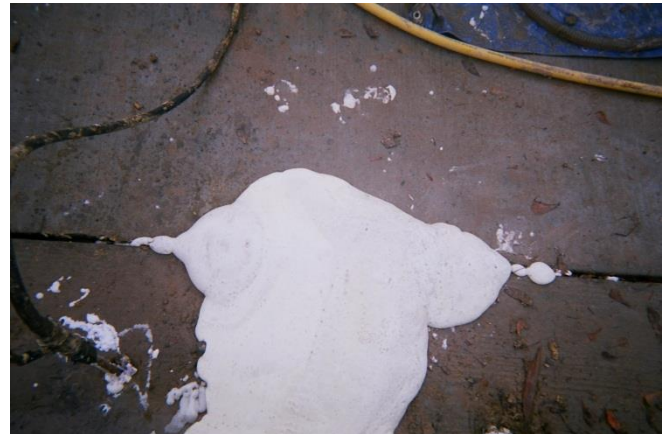
The above pictures show how well HyperFlex migrated through the porous, sandy soil. On the left is a picture of a storm drain and on the right the road bed itself.

We then inserted extensions into the holes and began pumping HyperFlex, moving from hole to hole to allow time for HyperFlex migration. Due to the porosity of the sandy fill, no packers were needed. The pattern was continued until all holes could take no more. Migration was excellent and in fact entered the storm drains through the faulty joints and also up into the road surface through the joints in the road bed.

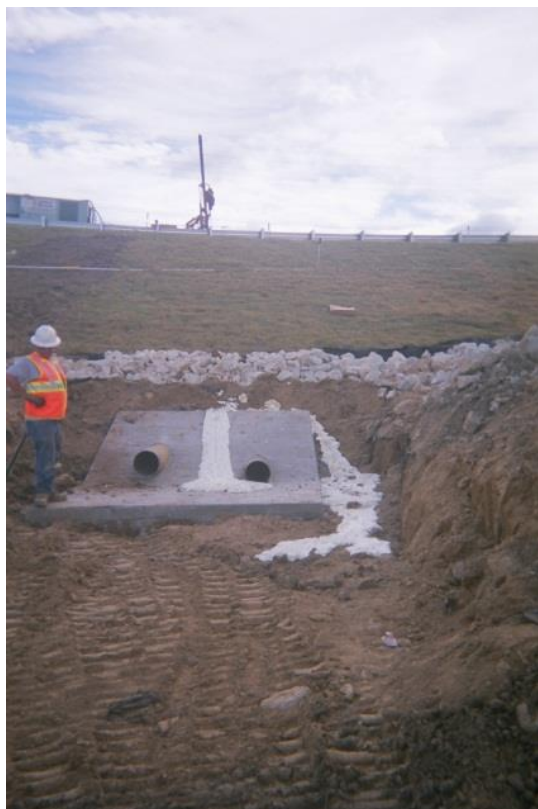
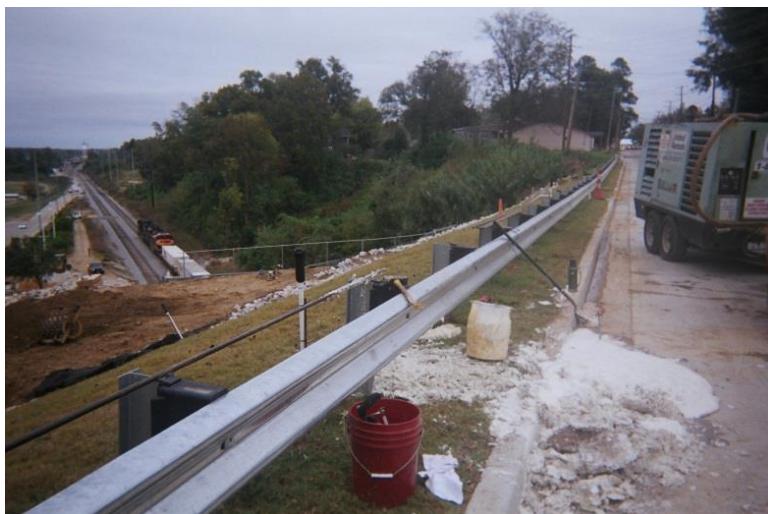
These pictures offer additional evidence of how HyperFlex seeks out & fills voids.
