## SealGuard / Sub-Technical Case Study – Ground Consolidation using HyperFlex

### Challenge Faced

## Our Solution

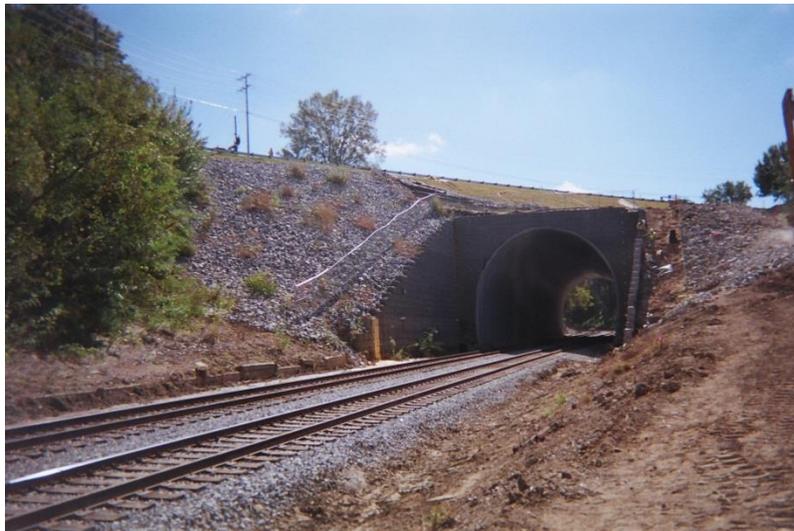
One of our most recent projects was sited at a newly constructed rail tunnel in southern Mississippi that was designed to carry a two lane roadway over it. This tunnel replaced 2 prior bridge structures, which had collapsed. An 800 foot corrugated metal tunnel liner was installed and the small valley back filled using sand and plastic grid material to hold it in place. The roadway was then rebuilt over the tunnel on the compacted fill material. Total depth of the tunnel is 75 feet from the rail bed to the road surface, 20 feet from the top of the tunnel to the road surface. When Hurricane Isaac hit the heavy rain exposed serious problems in the drainage system of the roadway and the design of the road itself. Improperly sealed precast storm drains leaked through the joints and the seals between slabs on the roadway failed. The volume and pressure created by the water scoured large quantities of sand fill from underneath the roadway, causing it to begin to sink. Engineers were concerned that this could lead to a collapse of the road bed with the associated danger to motorists and the tunnel itself.

The project engineers needed to consolidate the remaining fill from just below the roadway to the top of the tunnel. Other materials considered were cementitious grouts, which were ultimately rejected due to their weight and the resultant stress on the tunnel liner. Our HyperFlex product was selected for its ability to migrate good distances through the substrate and the fact that the reacted material in the consolidated ground would not increase the stress on the tunnel.

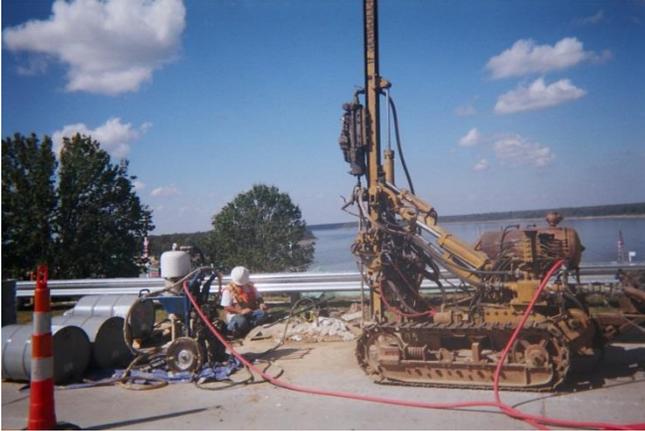
This is our air track machine used to drill bore holes.

Using our air track drill rig, we drilled a grid pattern of 10 and 20 foot deep bore holes. These were placed on 20 foot centers down through the road bed for the length of the tunnel.

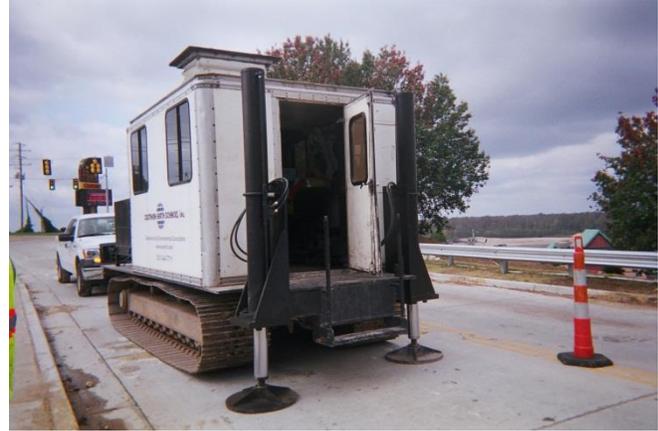
Compaction Penetrometer used to measure ground compaction after grouting.

This project took 6 weeks and amounted to 130,000 pounds of HyperFlex (14,300 gallons). Test bores and compaction tests performed upon cure showed the HyperFlex cured into a very dense (40 pcf versus 2 pcf at free rise) material that compacted the ground above and below it. This will enable the ground to carry the roadway safely into the foreseeable future

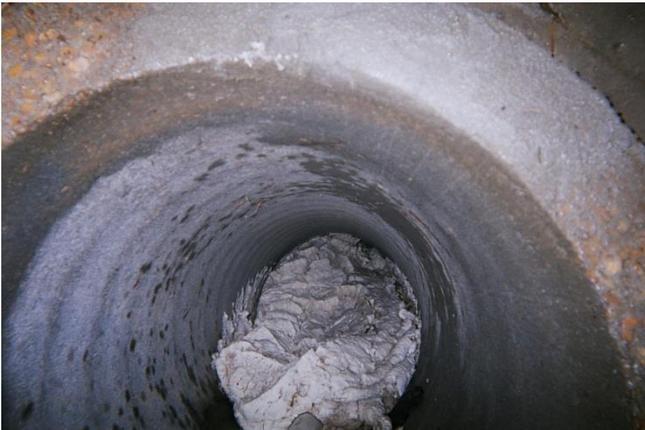
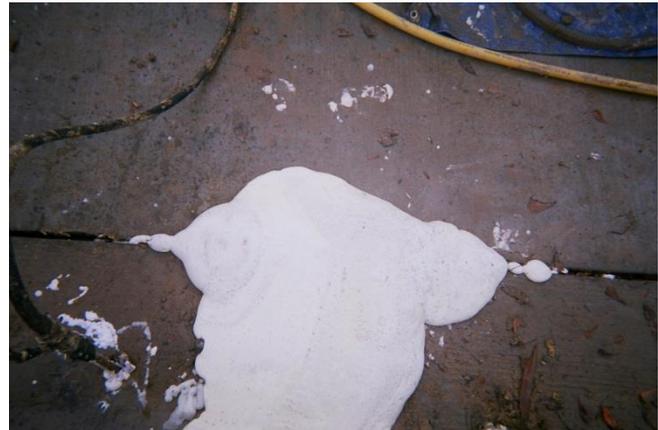
The above pictures show how well HyperFlex migrated through the porous, sandy soil. On the left is a picture of a storm drain and on the right the road bed itself.

We then inserted extensions into the holes and began pumping HyperFlex, moving from hole to hole to allow time for HyperFlex migration. Due to the porosity of the sandy fill, no packers were needed. The pattern was continued until all holes could take no more. Migration was excellent and in fact entered the storm drains through the faulty joints and also up into the road surface through the joints in the road bed.

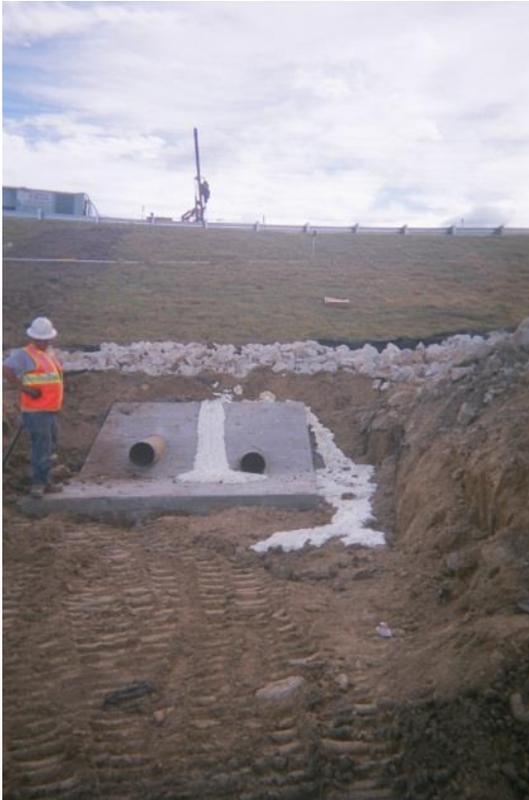
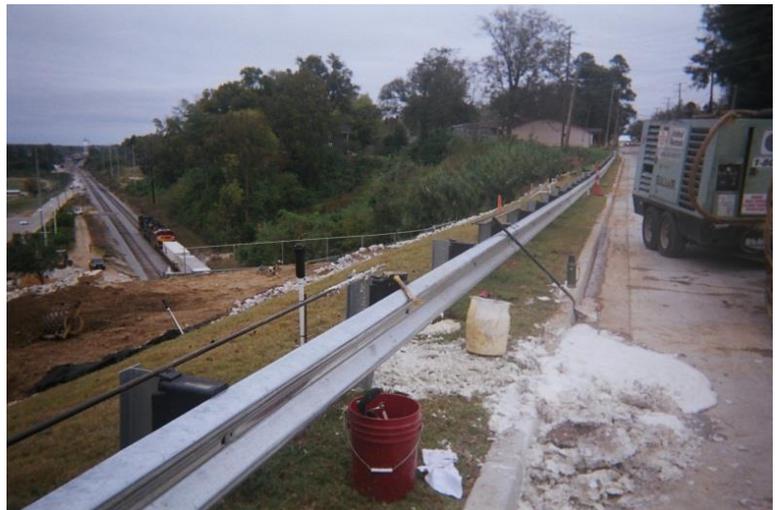
These pictures offer additional evidence of how HyperFlex seeks out & fills voids.
