Case Study  
Soil Stabilization / Rotary Kiln / Virginia USA

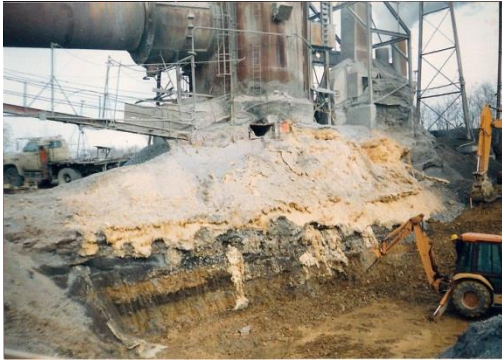
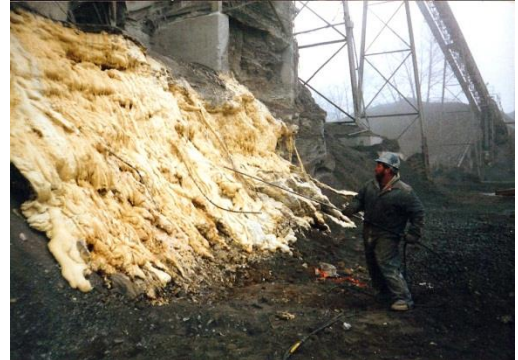
A Virginia, USA limestone mine needed to move a large rotary kiln. However, the construction of the new pad necessitated cutting into the ground underneath the existing location of the kiln. The ground was a compacted blend of gravels, clay and sedimentary rock.

Sub-Technical, using extensions, injected a single component urethane in a pattern reaching approximately half way underneath the kiln. Upon completion, the rock and soil were joined in a monolithic structure, holding the strata together. Excavators were then able to cut away the required section of the hillside, allowing for the preparation of the new pad.

Urethane stabilized and strengthened the substrate beneath the kiln, allowing for the safe excavation of the new kiln pad.
